CIVIL AERONAUTICS BOARD

ACCIDENT INVESTIGATION REPORT

UNITED AIR LINES, INC.,—FORT COLLINS, COLORADO, JUNE 30, 1951

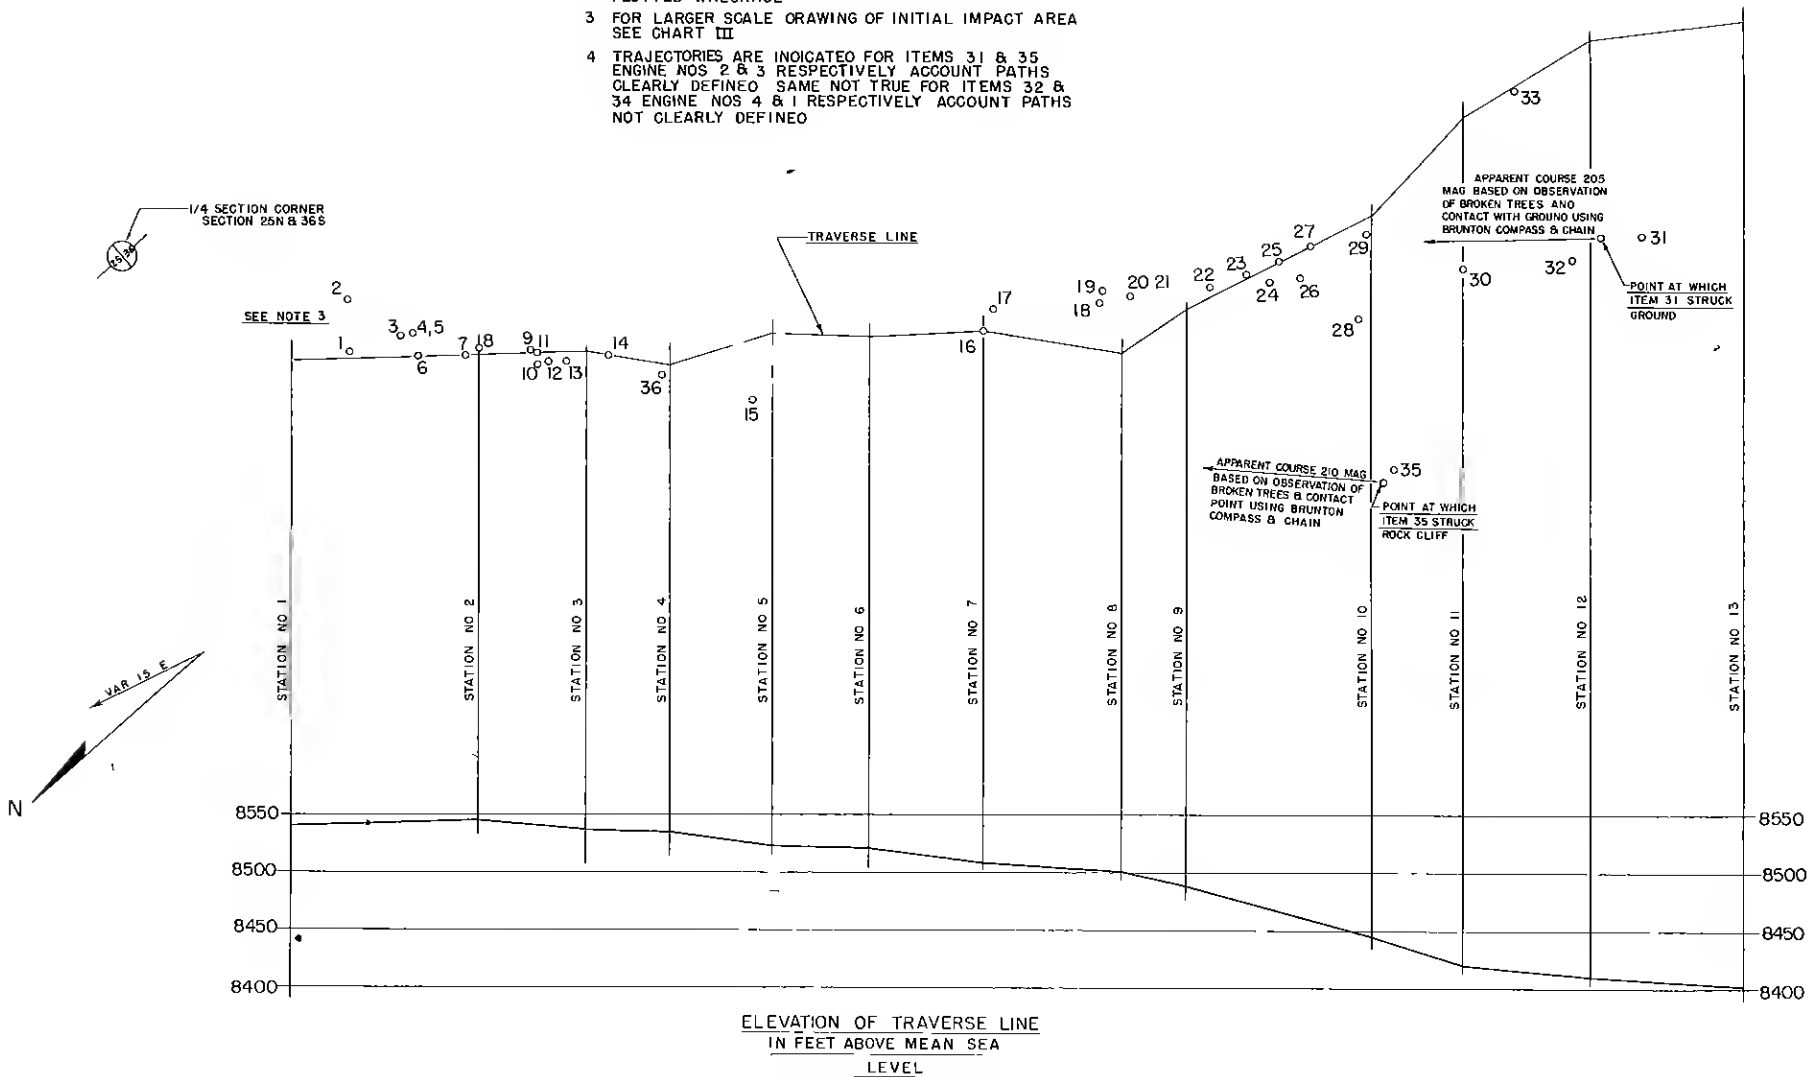
CHART II - DISTRIBUTION OF WRECKAGE
UNITED AIR LINES ACCIDENT
OC-6 N37543 AT CRYSTAL MOUNTAIN
NEAR FORT COLLINS COLORADO JUNE 30 1951

traveled in a straight line 225 feet, then bounced into the air again, and came to rest 465 feet farther on. The aircraft was demolished, and aircraft parts and assemblies were strewn over a 1,400-foot area.⁵ Localized fires occurred after impact.

An examination of the wreckage revealed that at the time of impact the landing gear and flaps were retracted. During this examination nothing was found to indicate that there was any structural failure of the aircraft or its components prior to impact. Numerous pieces of mail, paper, cabin insulation and other light materials were found north-northeast of the point of impact along the flight path a distance of two miles from the scene of the accident. All of the debris was heavily spotted with engine oil and several pieces showed evidence of burning, indicating that at the time of impact an explosion occurred which blew this material aloft and that it was carried away by the eddying wind currents. Identical material which was also spotted with engine oil was found at the scene of the accident.

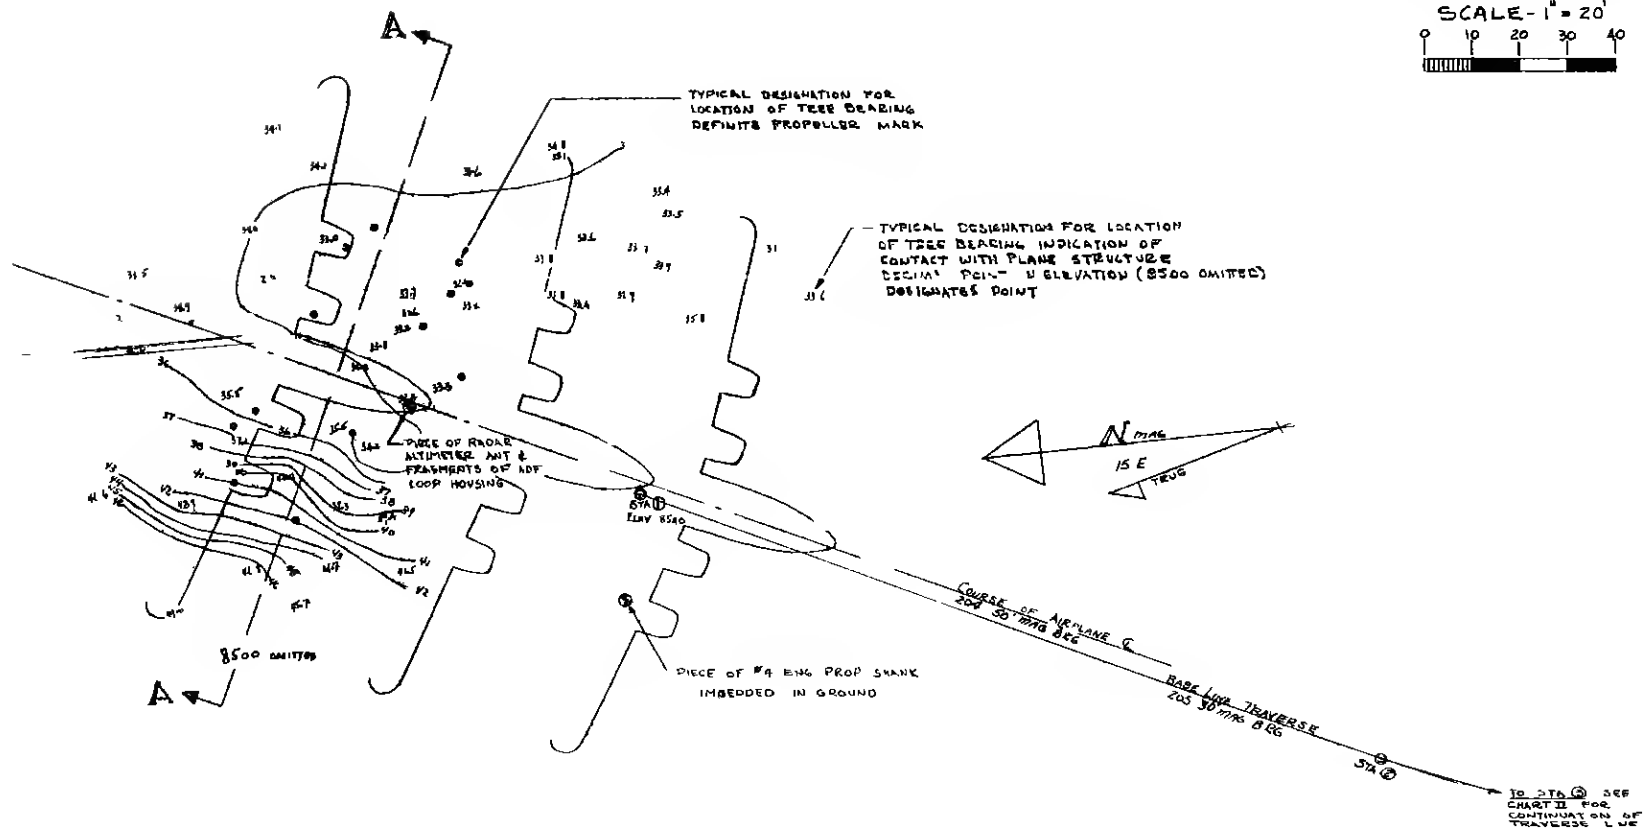
CHART III-INITIAL IMPACT AREA

Investigation disclosed from the direction of the swath cut through the trees that the aircraft struck the side of Crystal Mountain while flying with its left wing low and on an approximate magnetic heading of 210 degrees. The altitude at the point of impact was found to be 8,540 feet MSL. After initial contact with the trees the aircraft continued to travel approximately sixty feet, at which point it struck the ground. From here it

SECT A-A
ROTATED APPROX 70° E
SECTION REPRESENTS LOWER SURFACE
OF DC-6 AIRPLANE FROM WING TIP TO
WING TIP AND ITS DISPLACEMENT FROM
A LINE PARALLEL TO HORIZON AS
DETERMINED FROM BROKEN TREE TOPS

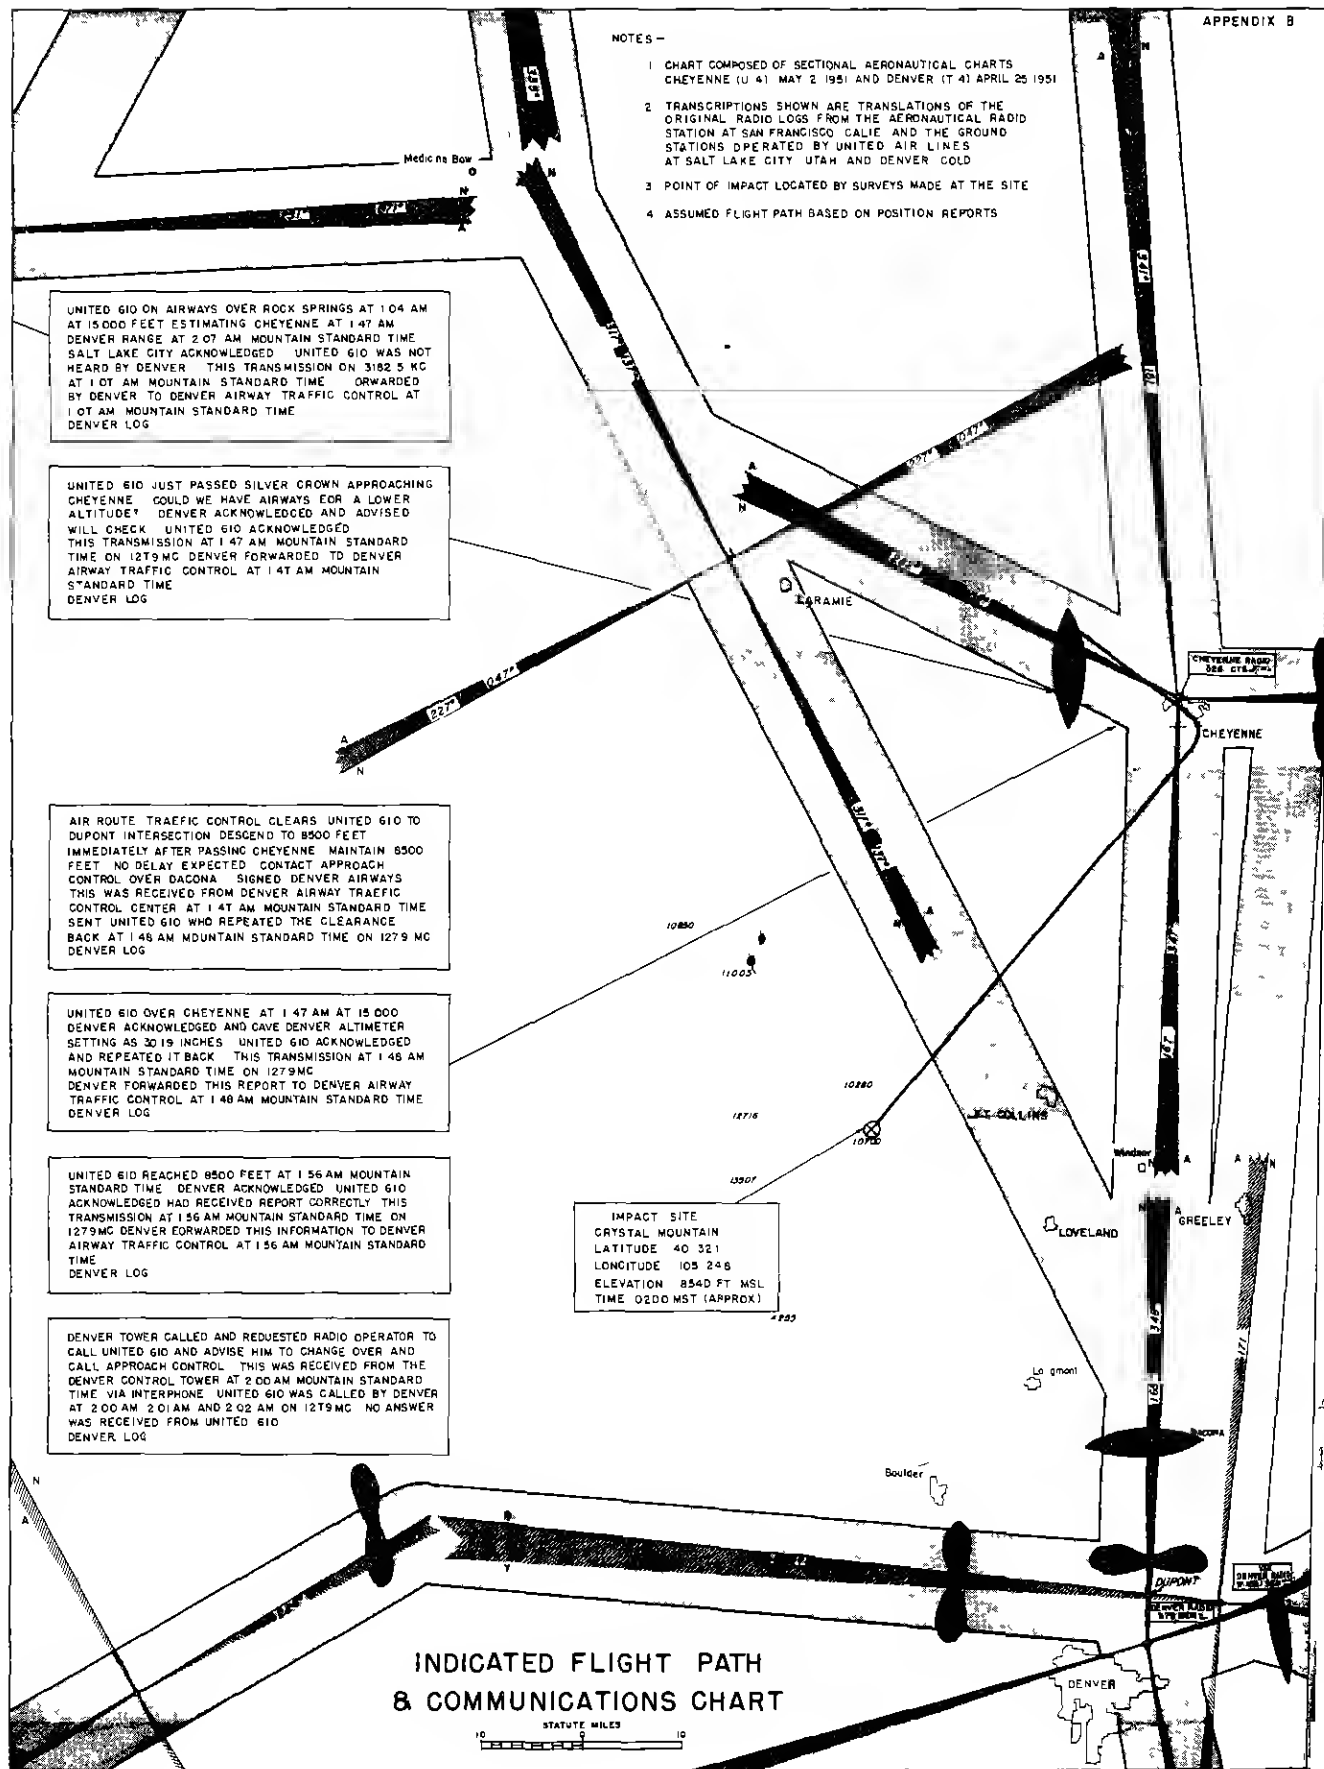
INDICATED FLIGHT PATH & COMMUNICATIONS CHART

As a part of the investigation, an exploratory flight was made in a similar type aircraft to determine the credibility of the probable flight path of the subject aircraft between Cheyenne and the scene of the crash⁶. In an effort to duplicate the assumed track of Flight 610, the test flight crossed the Cheyenne range station from the northwest at 15,000 feet, and a shallow descending right turn was started toward a heading of 210 degrees magnetic. Two minutes were required to arrive at this heading. Continuing on this heading, a descent of 700 to 1,000 feet per minute was maintained at an indicated air speed of 245 miles per hour. Descent from 15,000 to 8,500 feet MSL required seven minutes. Four minutes later the flight arrived over the scene of the accident after climbing slightly to clear the ridge. Thirteen minutes were required to fly from Cheyenne to the scene of the accident. This time, added to the time the aircraft reported crossing Cheyenne, closely approximates the assumed time of the crash.

IMPACT SITE
CRYSTAL MOUNTAIN
LATITUDE 40 32.1
LONGITUDE 105 24.8
ELEVATION 8540 FT MSL
TIME 0200 MST (APPROX)
